## Chimney Inspection Report

**Date:** 6/05/2021

**Service Address:** Valley Forge Casino Resort

**Inspector:** Mr. Bear

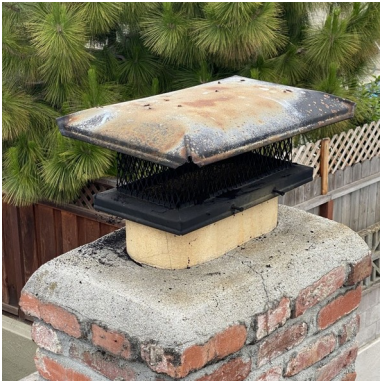
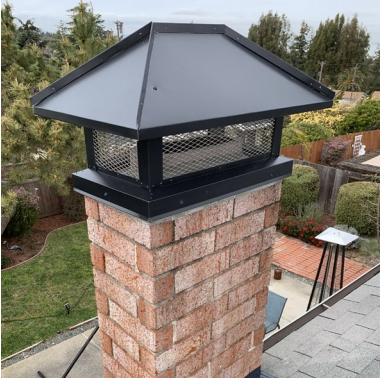
## Cap

<b>Defect:</b>	Chimney cap is missing or damaged

<b>Additional Notes:</b>	Chimney caps prevent leaves, animals, water, etc., from entering the chimney flue. They also prevent sparks from landing on the roof. Not having a properly functioning chimney cap can lead to increased fire risk.	
<b>Recommended Repair:</b>	Install an outside mount chimney cap.

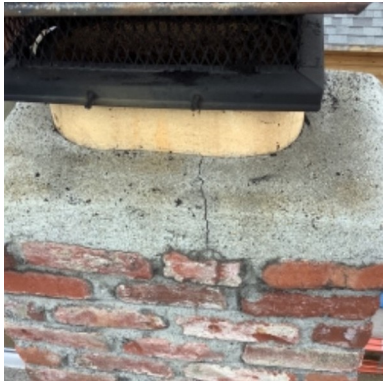
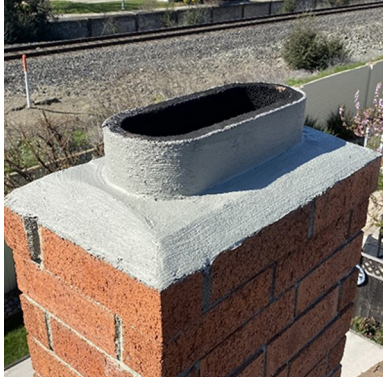
## Crown

<b>Defect:</b>	Upper crown is cracked

<b>Additional Notes:</b>	Damage to the crown is often caused by the freeze/thaw cycle of water in cracks. If the crown is not sealed, cracks will continue to grow and allow water intrusion and damage to the chimney stack.	
<b>Recommended Repair:</b>	Repair the crown with sealant

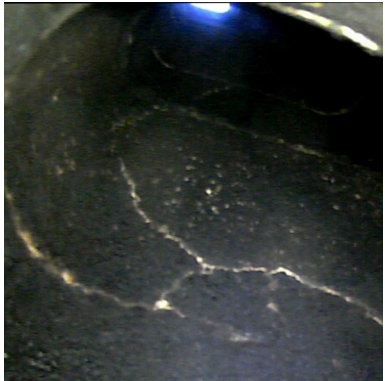
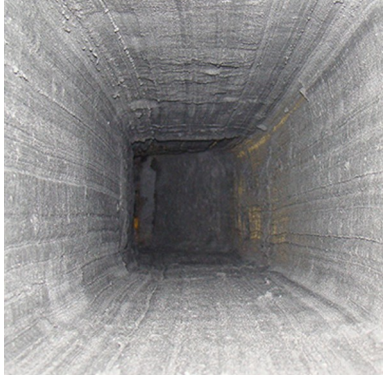
## Flue Liner

<b>Defect:</b>	Flue liner is cracked, spalling, or broken

<b>Additional Notes:</b>	Damage to flue tiles is often caused by rapid heating and cooling inside the chimney. A non functioning flue liner can lead to possible heat transfer to combustibles.	
<b>Recommended Repair:</b>	Apply Heatshield chimney liner repair system

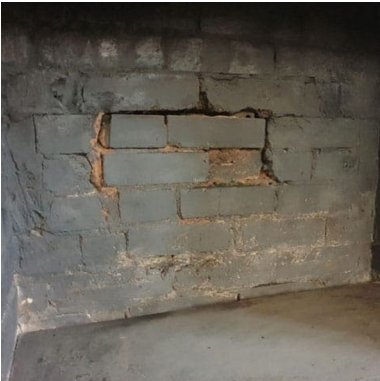
## Firebox

<b>Defect:</b>	Firebox walls are cracked

<b>Additional Notes:</b>	Damage to the firebox can be caused by improper construction materials or methods, or overfiring. Continued use of a damaged firebox can lead to CO leaks, heat transfer to combustibles, or more extensive damage.	
<b>Recommended Repair:</b>	Rebuild the firebox.
