## Chimney Inspection Report

**Date:** 6/05/2021

**Service Address:** Valley Forge Casino Resort

**Inspector:** Mr. Bear

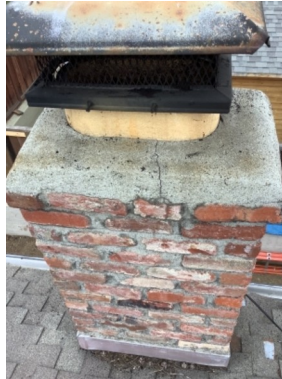
Crown

<b>Defect:</b>	Upper crown is cracked

<b>Additional Notes:</b>	Damage to the crown is often caused by the freeze/thaw cycle of water in cracks. If the crown is not sealed, cracks will continue to grow and allow water intrusion and damage to the chimney stack.	
<b>Recommended Repair:</b>	Repair the crown with sealant
